Soils & Water Testing

Laytonville Rancheria - 2017

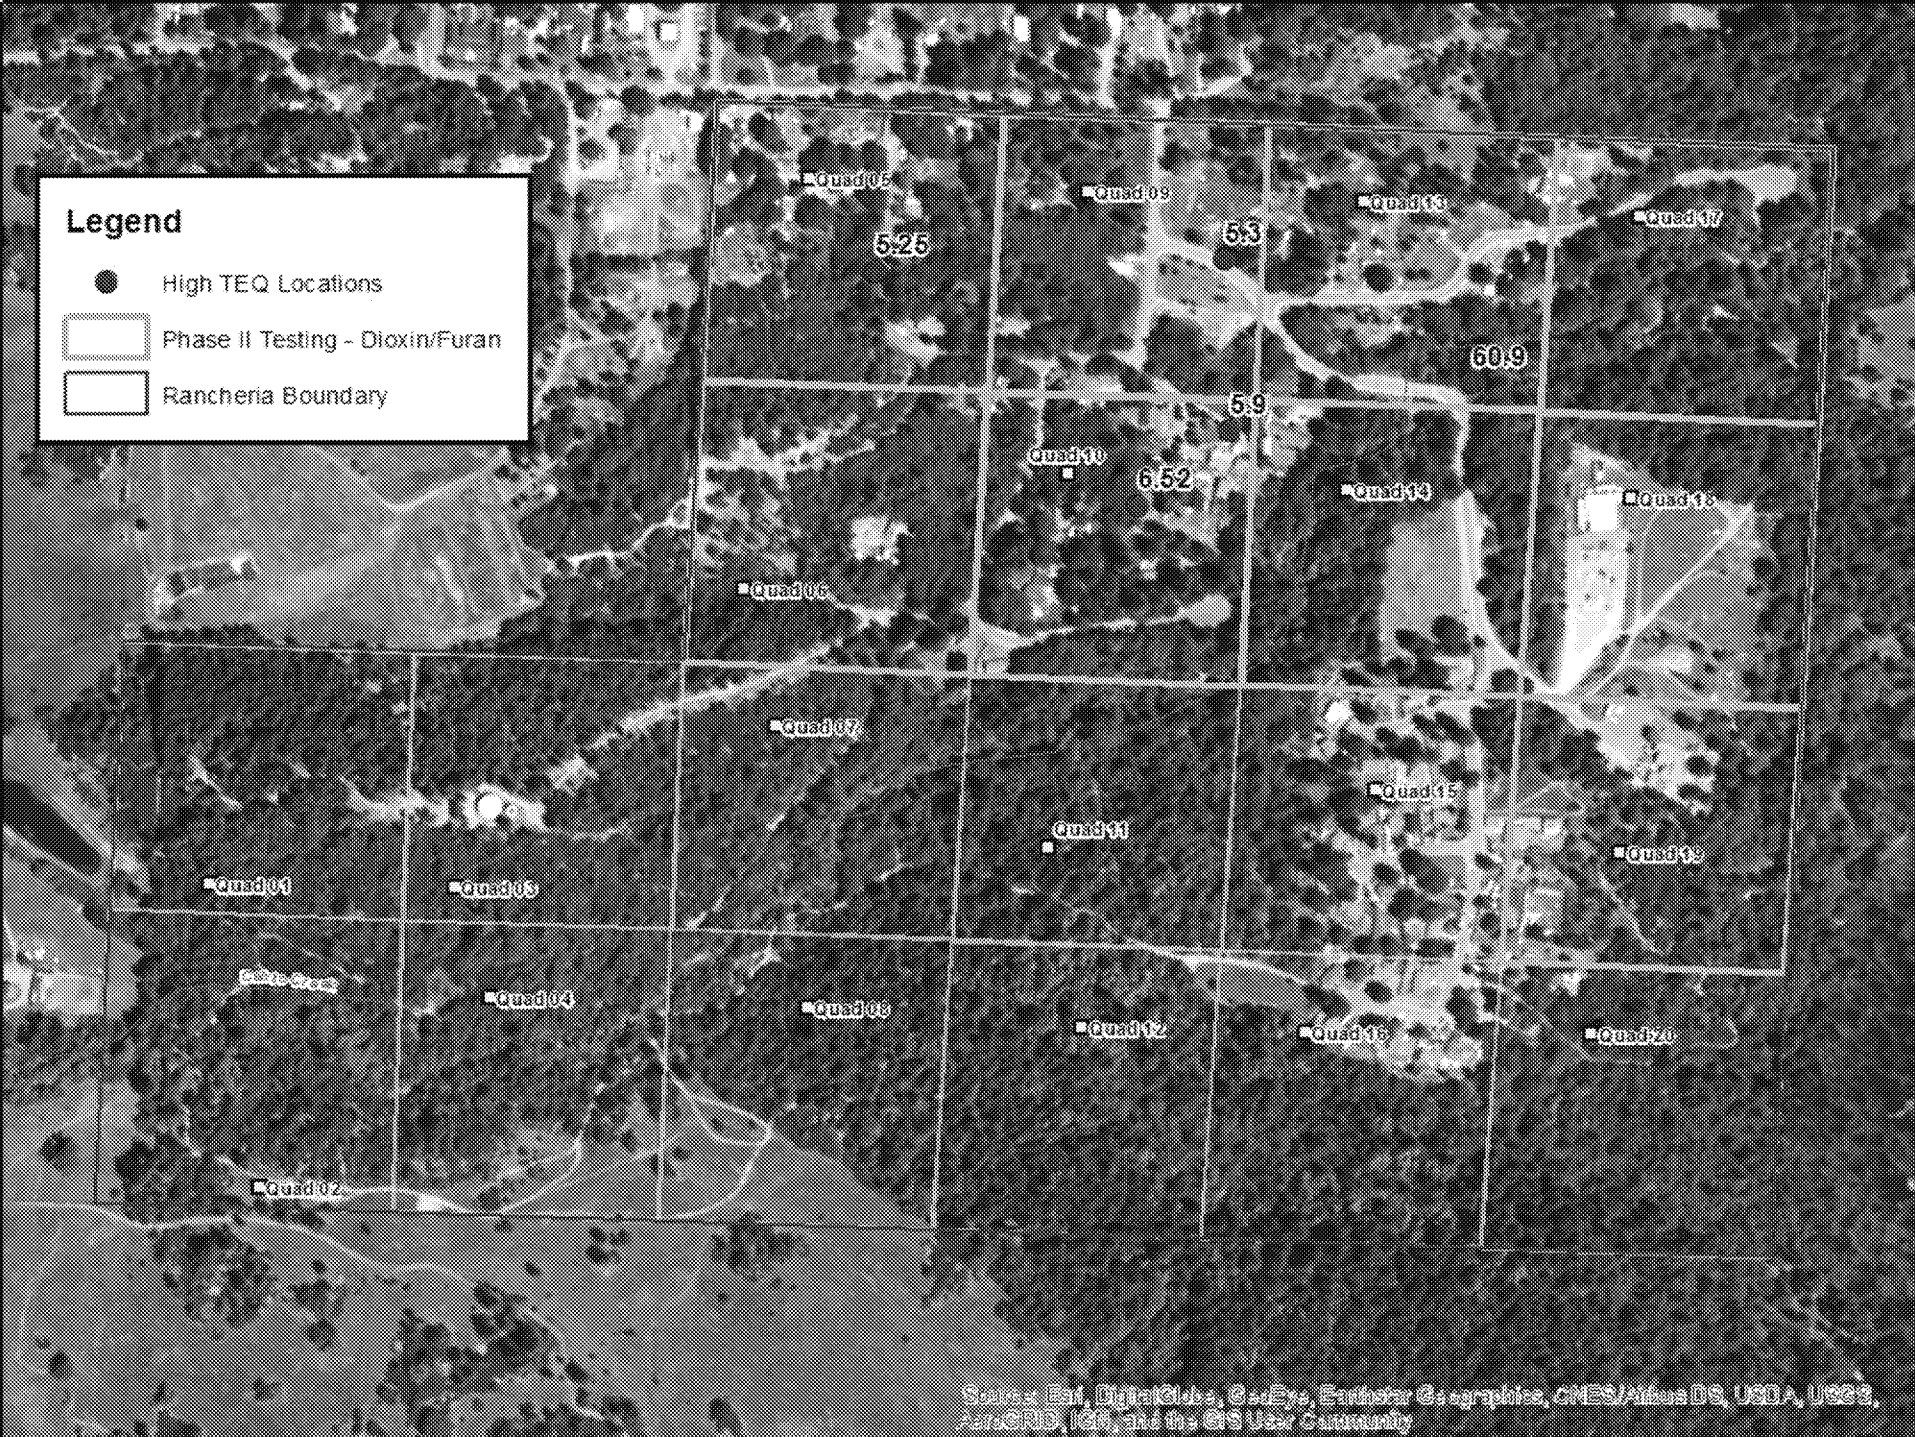
- 45 soil samples were taken and tested for Dioxin/Furan toxicity levels.
- 5 locations had a TEQ higher than RSL of 4.8.

- High TEQ Locations
- Phase II Testing - Dioxin/Furan
- Rancheria Boundary

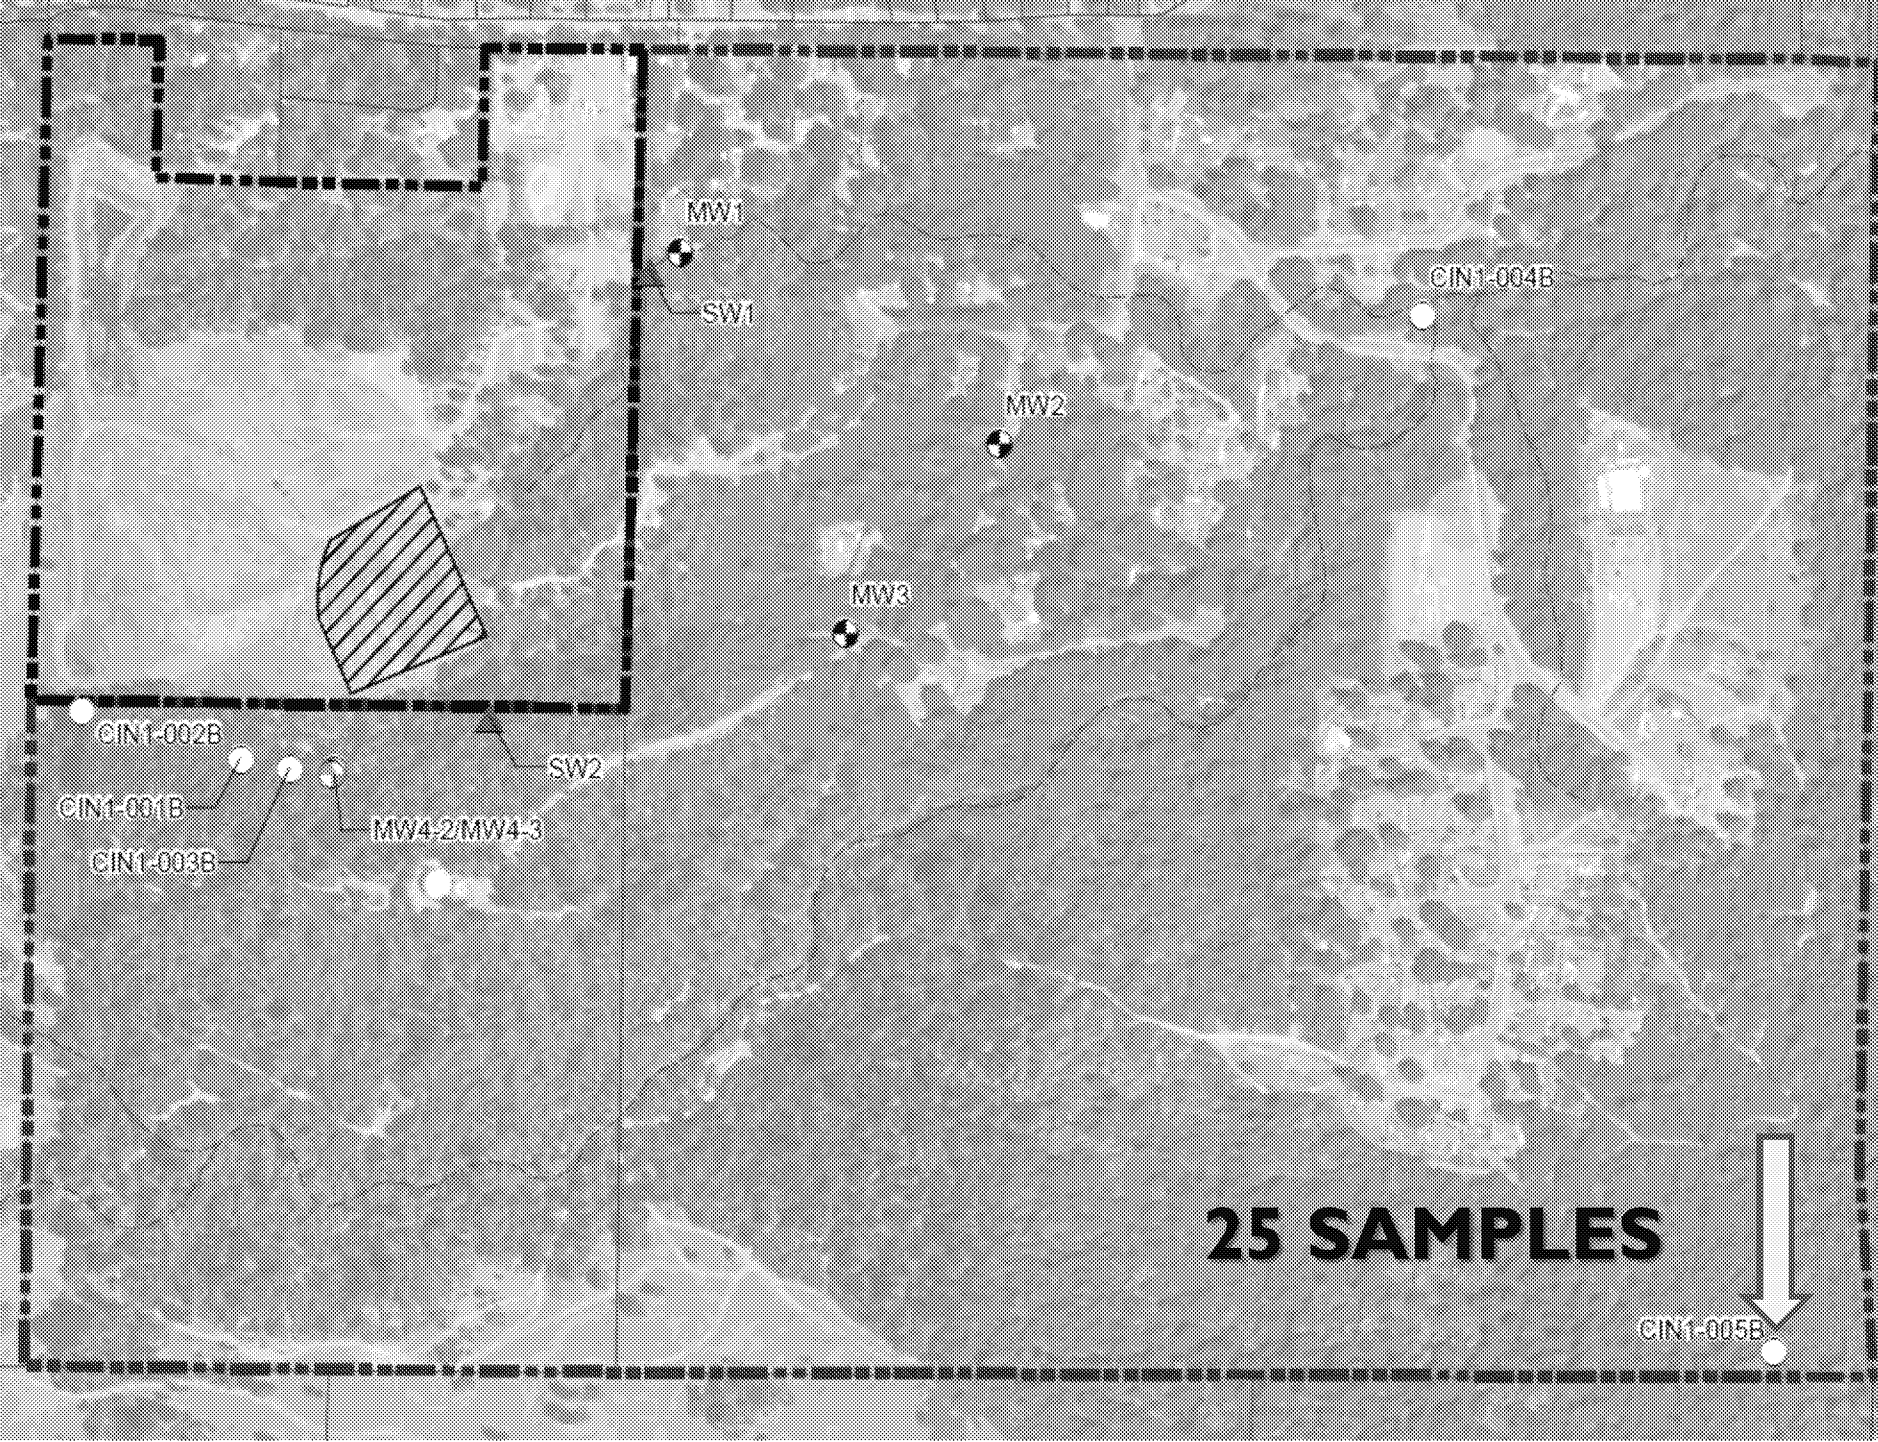
Ahtna Sample #CIN1-002B

- Samples were taken in a radial pattern based on concentric circles at 10 ft. intervals.

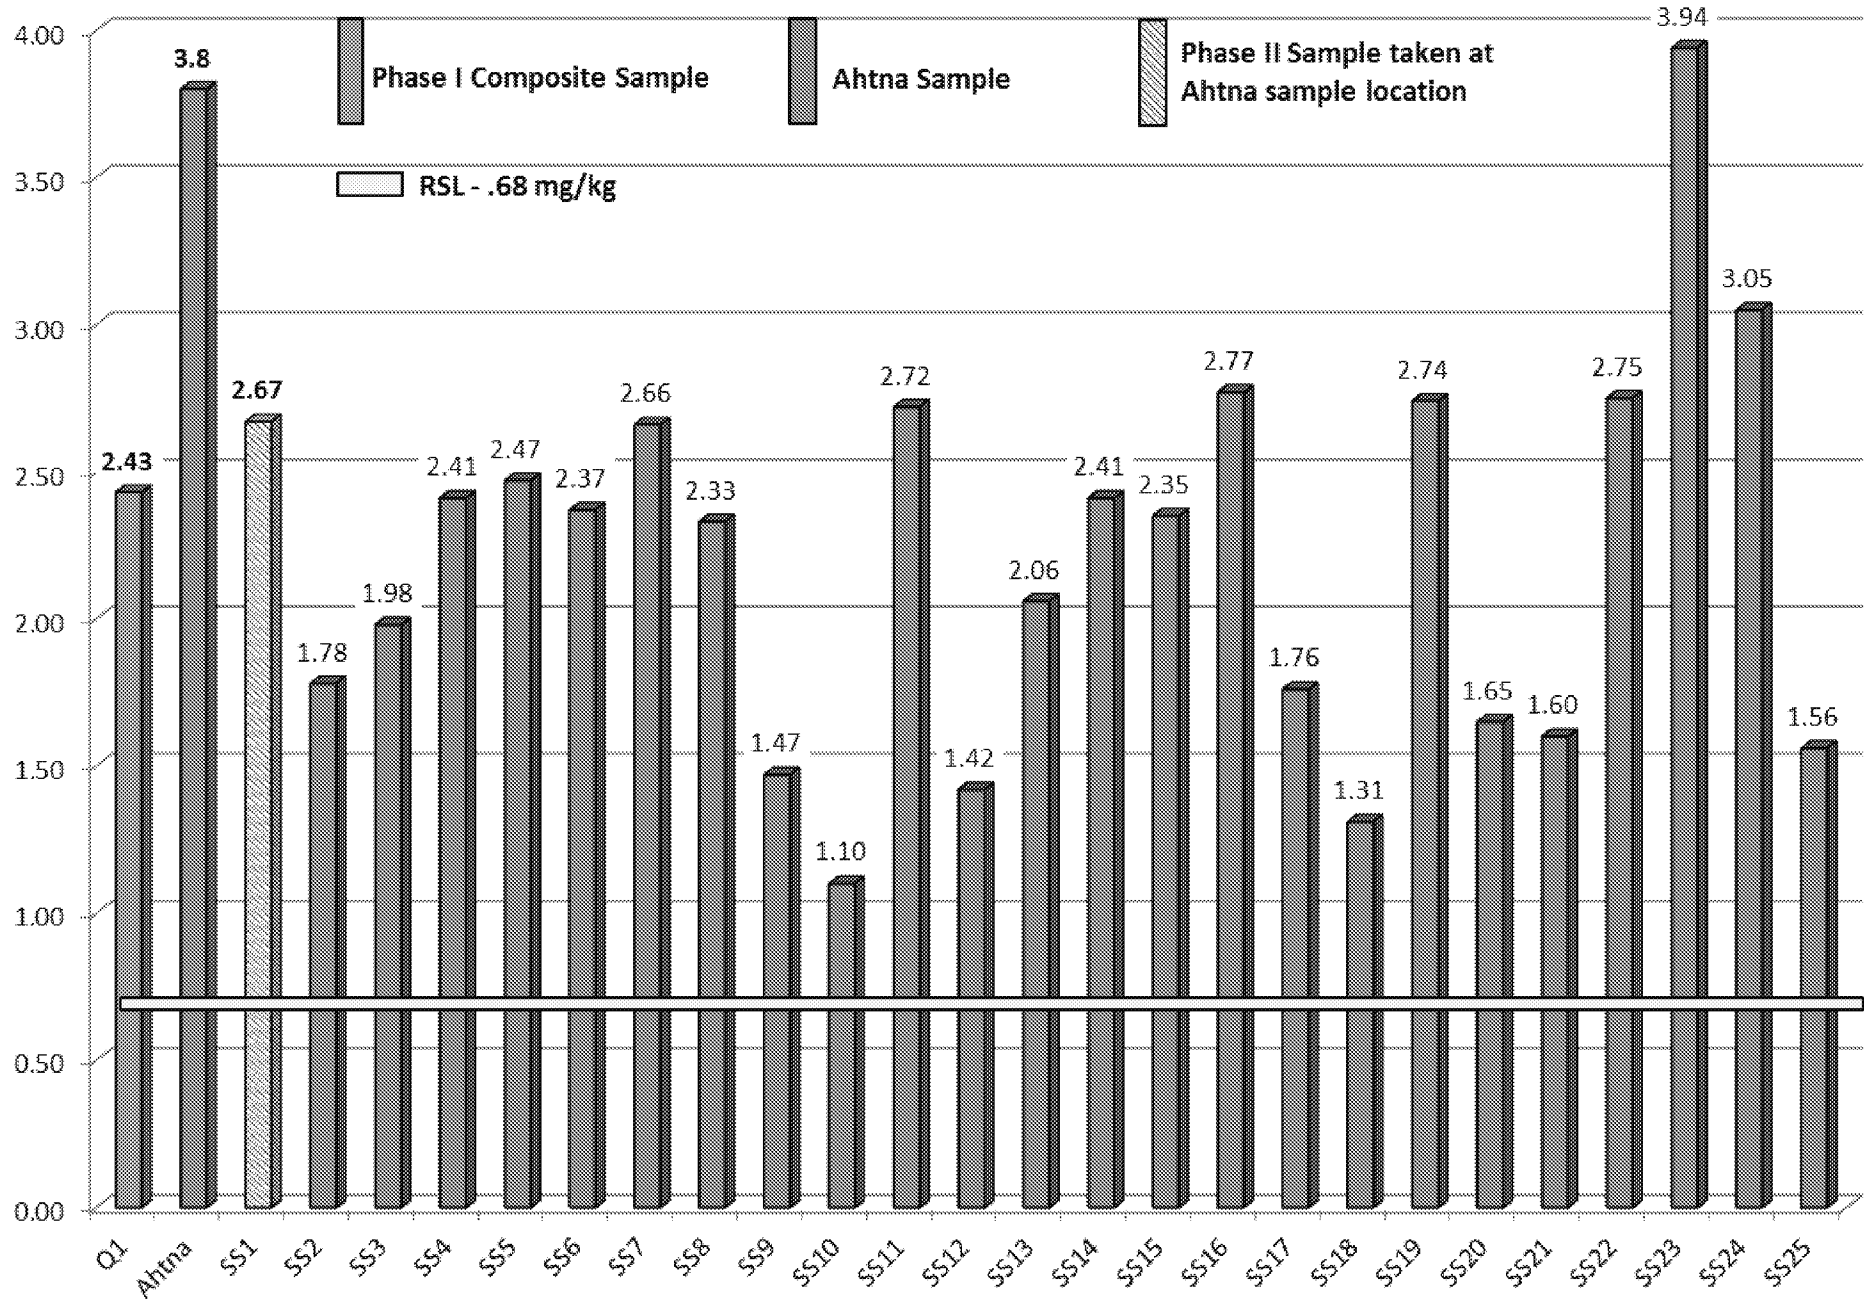
Quadrant 1 - Arsenic

- Soil samples results were similar to Phase I test results (composite samples).
- Test results confirmed presence of Arsenic.

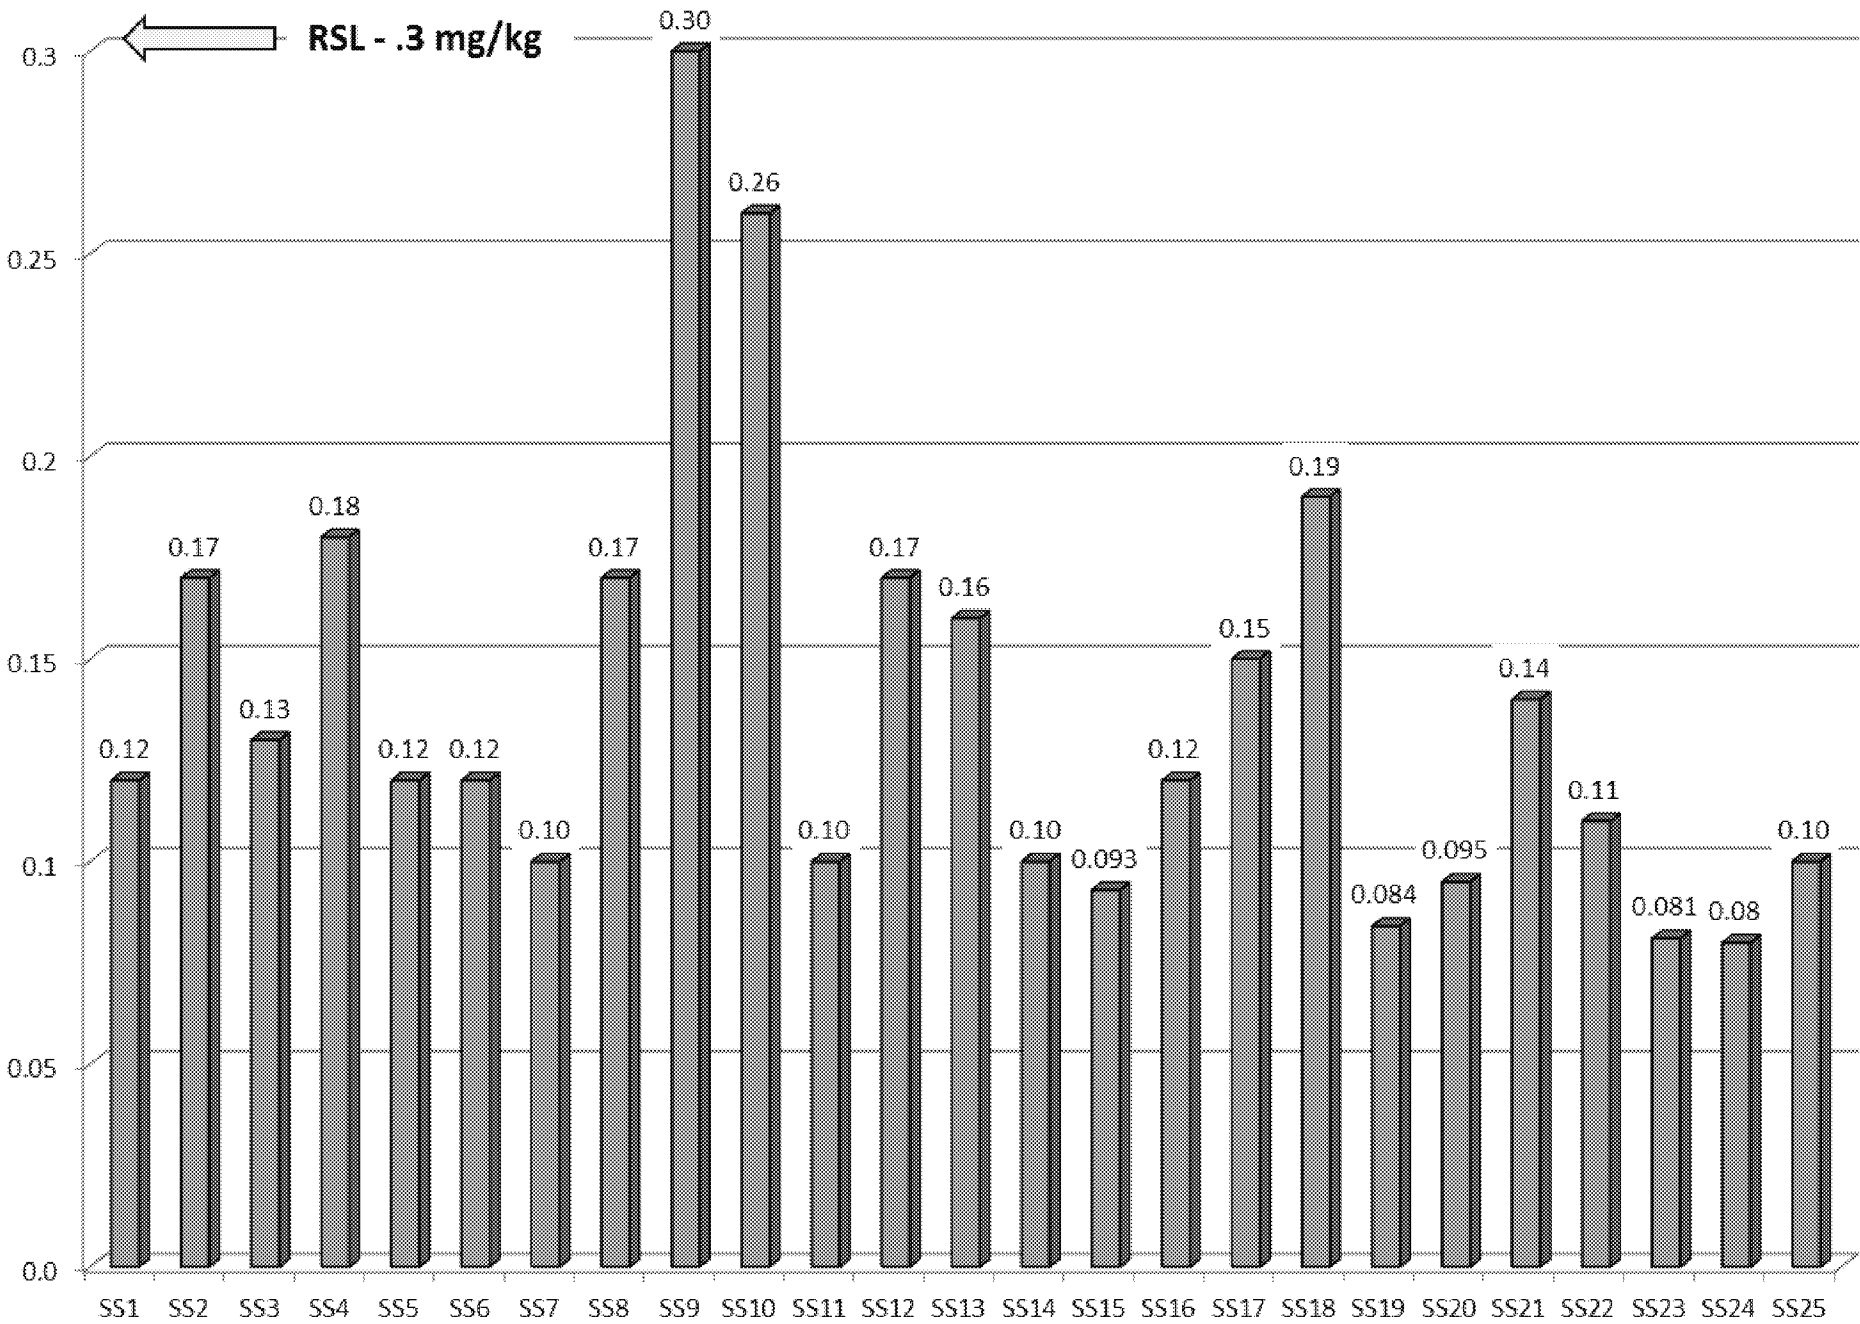
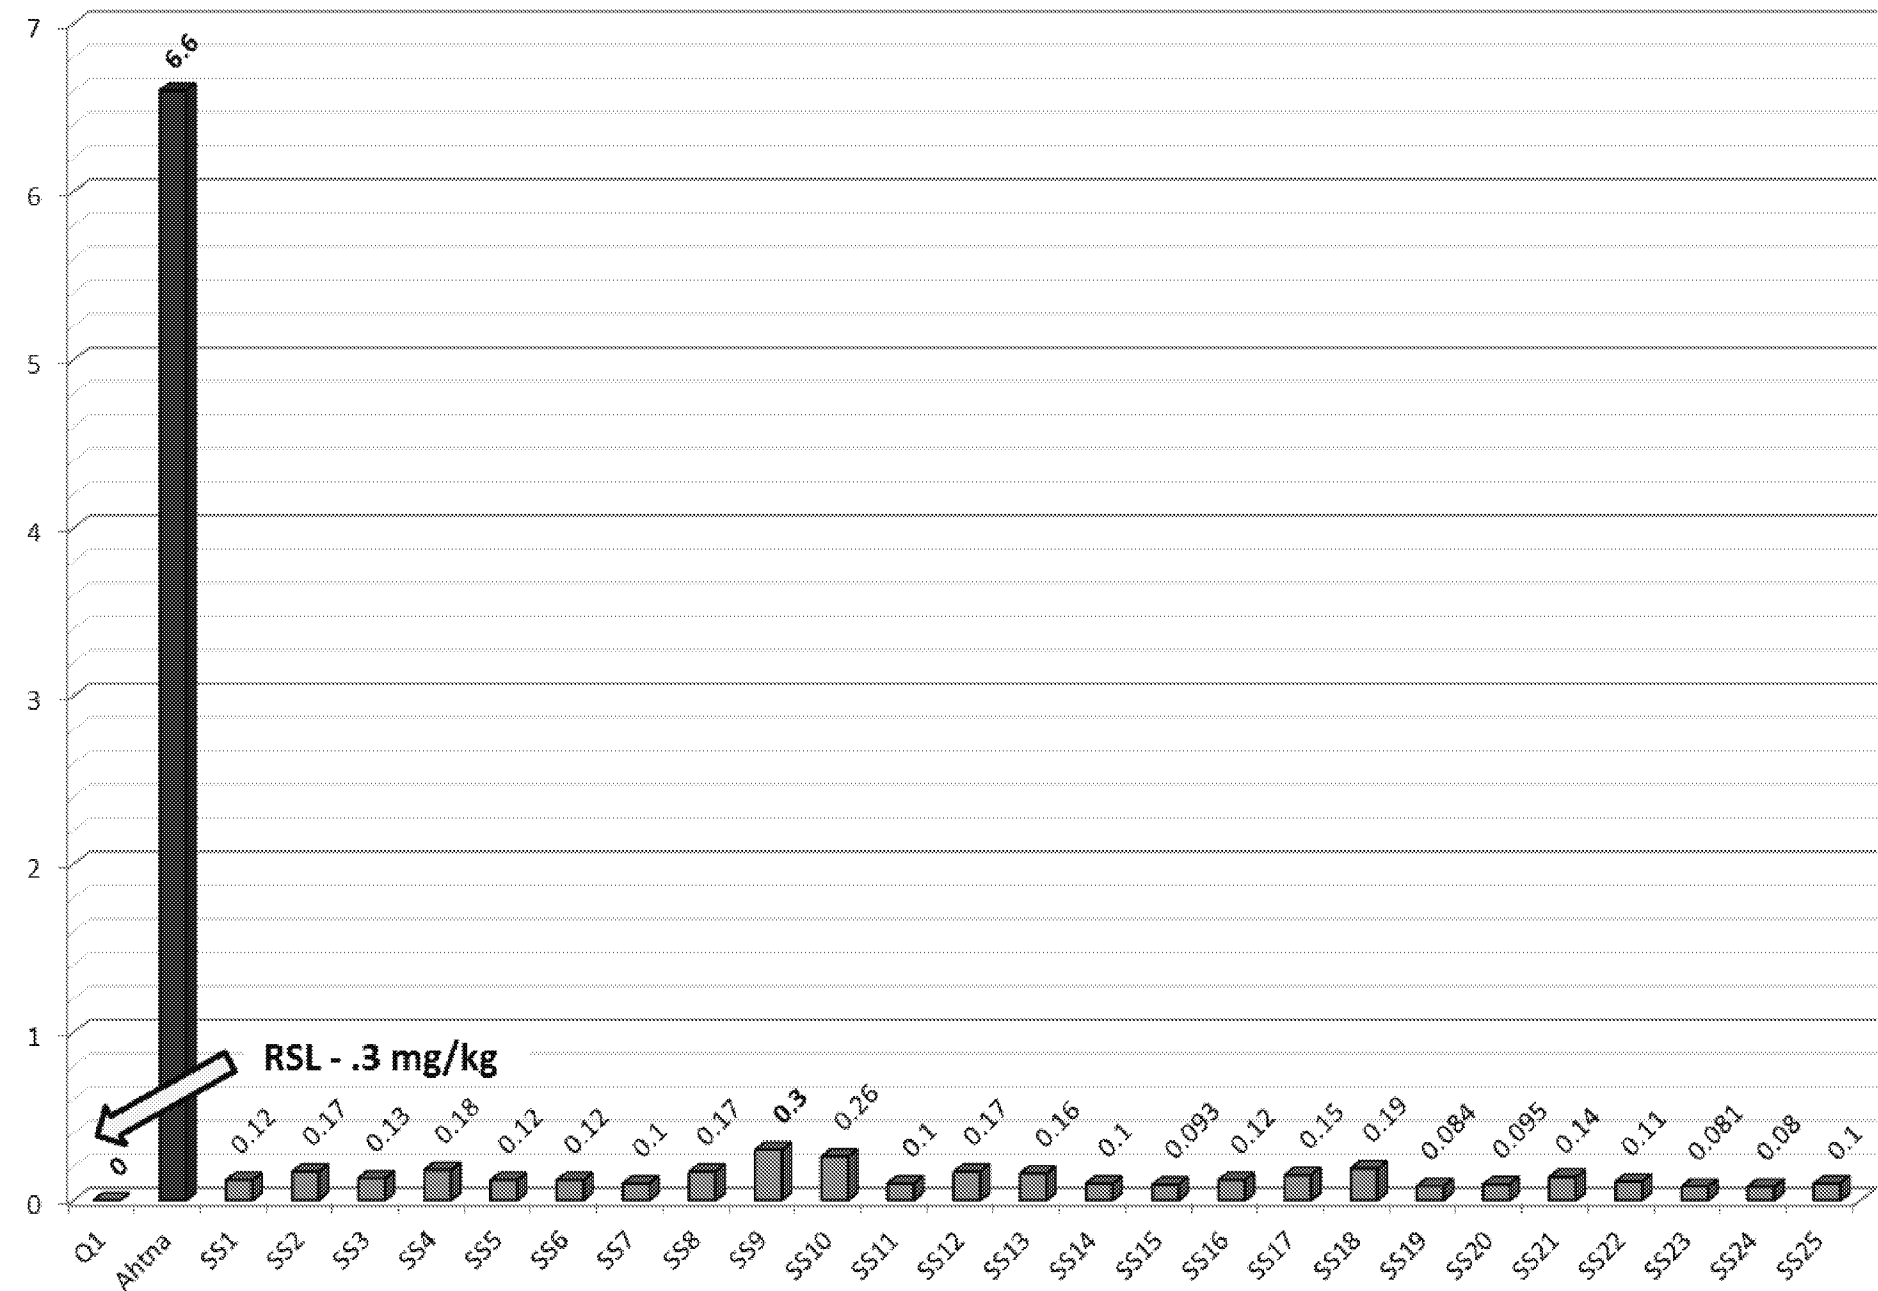
Hexavalent Chromium - Quadrant 1

- Test results detected Hexavalent Chromium, but at levels well below what was first reported.
